Capilano Park Boat Launch - 2023

Site Information and Background:

Name: Capilano Park Boat Launch

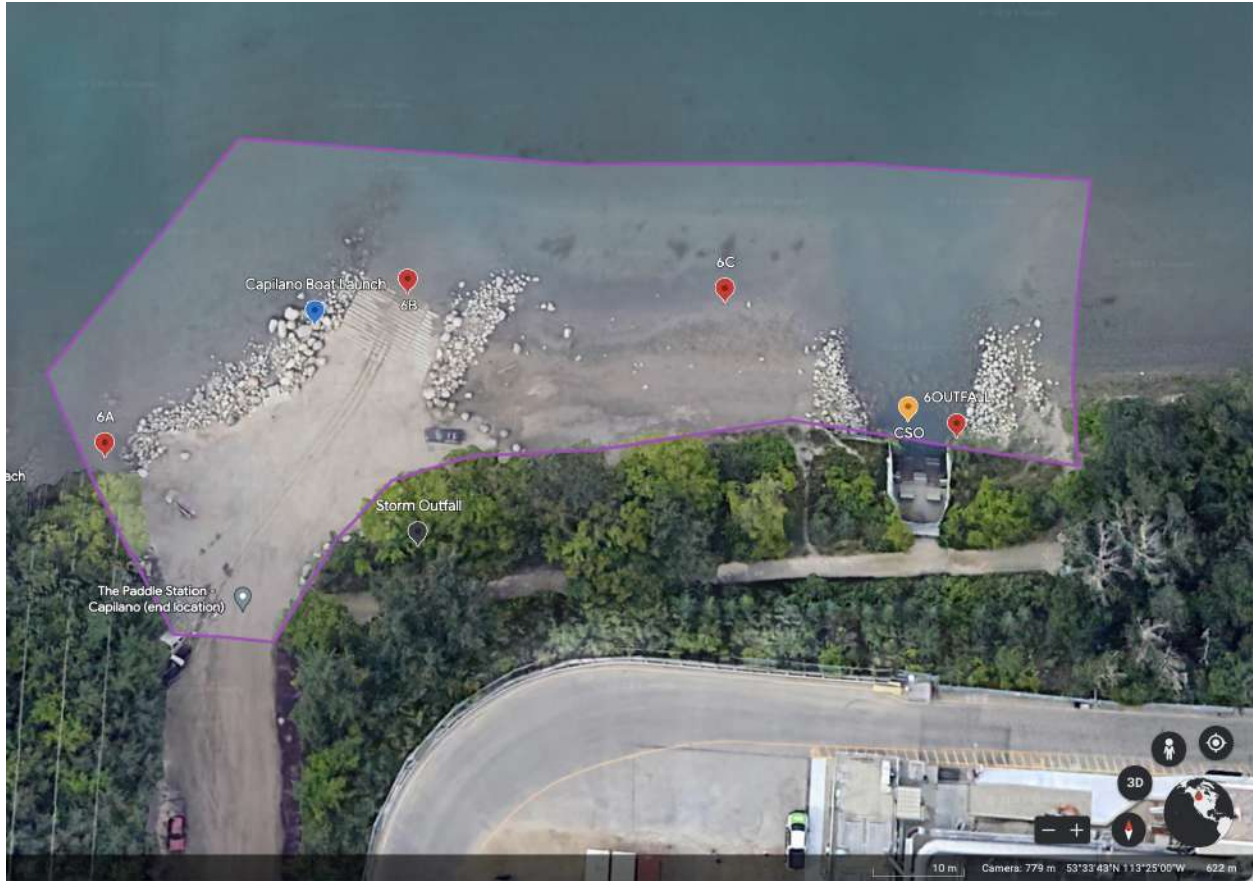
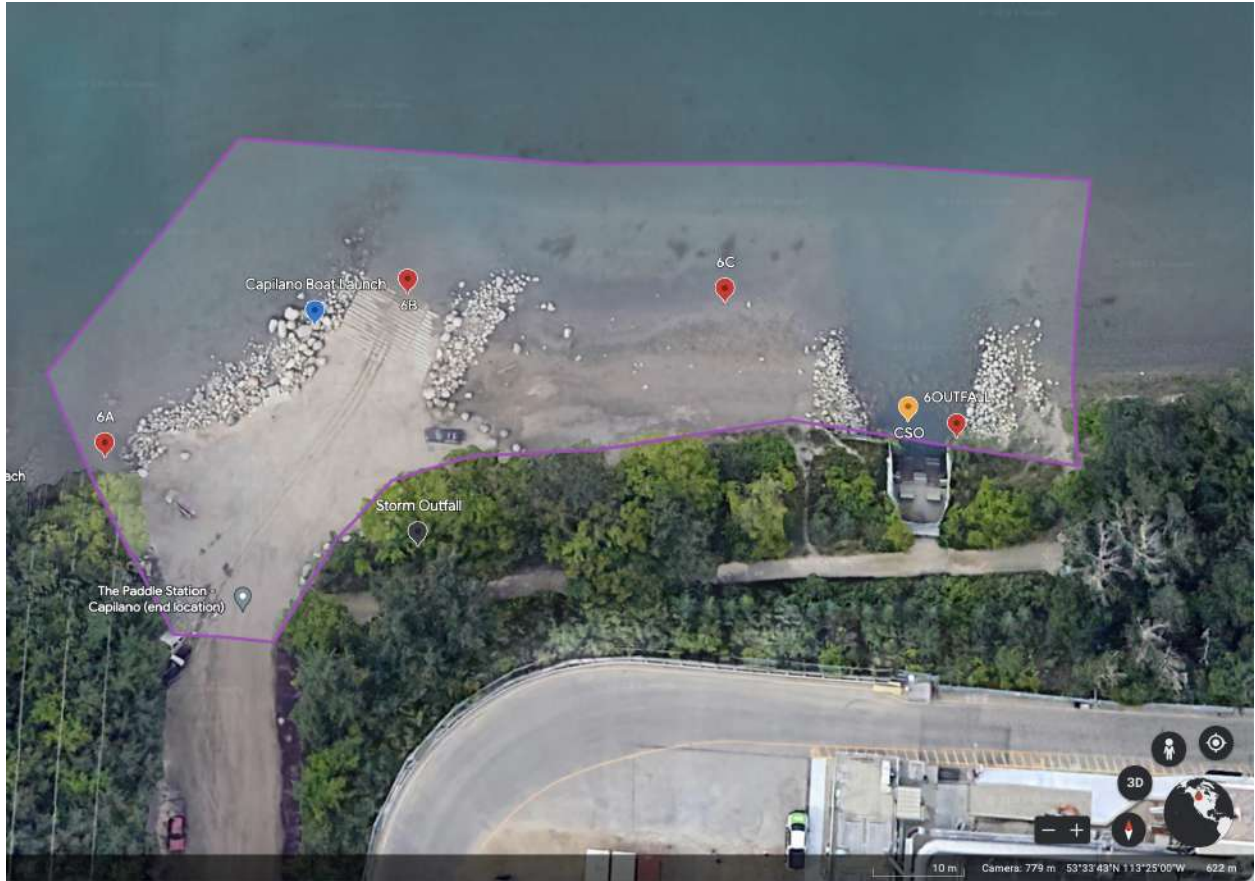
Figure 1b: Map of Capilano Boat Launch Site with Zone of local influence. CSO/Storm Outfall is included in the zone of local influence as there is a bit of an eddy that could bring any contamination from this a bit upstream closer to our sampling site.
