Hospital Beach - 2023

Site Information and Background:

Responsible Authority: Swim Drink Fish Canada - Kingston Water Monitoring Hub

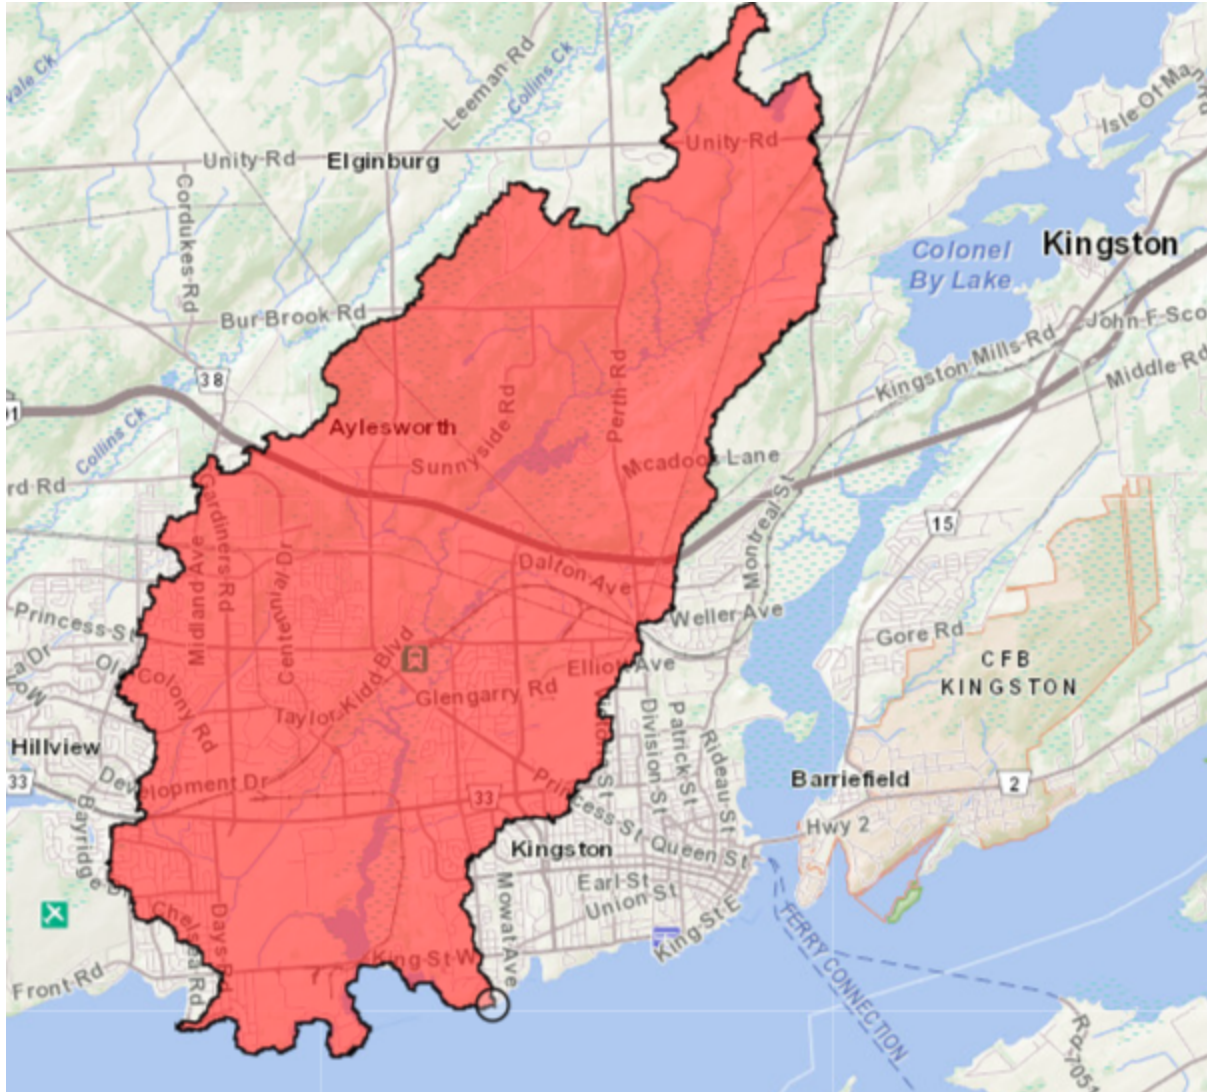
Figure 2. Map of Watershed for Hospital Beach..

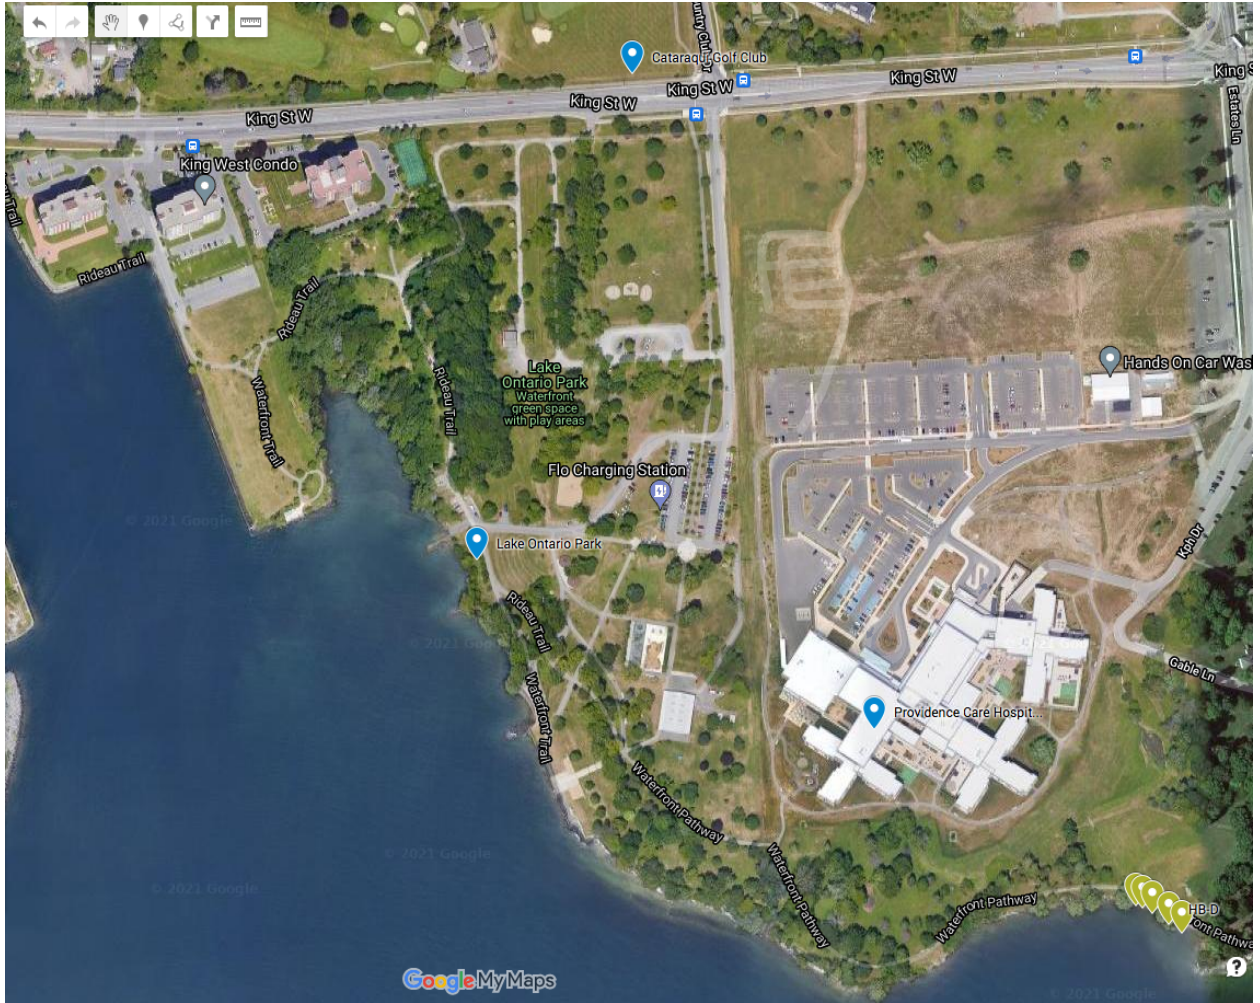
Figure 3. Hospital Beach sampling sites (green), and Providence Care Hospital, Catarqui Golf Club, and Lake Ontario Park (blue).

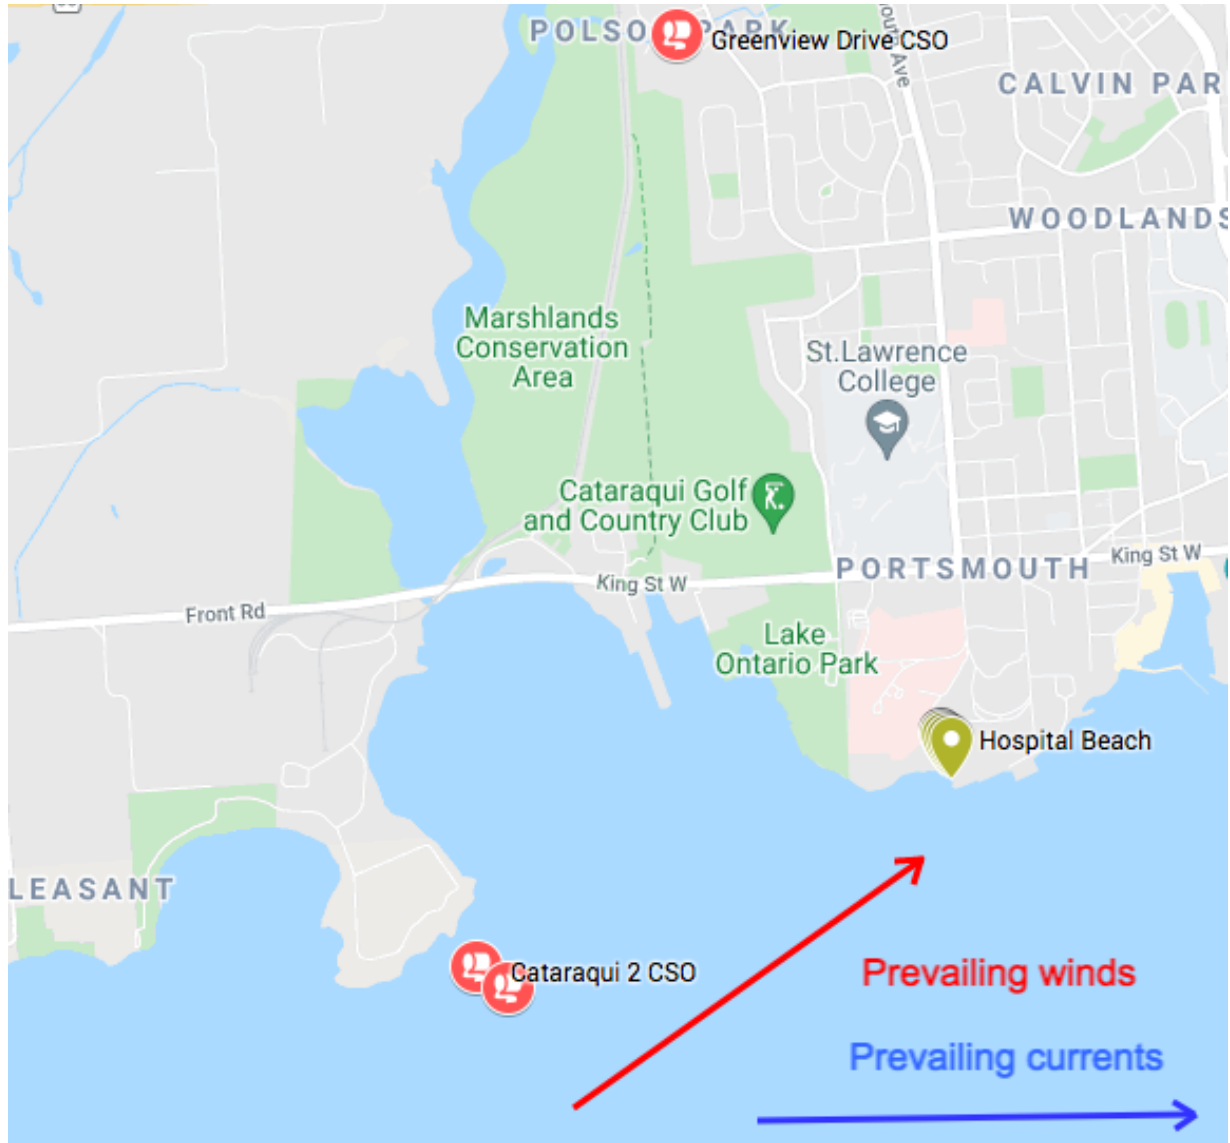
Hospital Beach is located on a large open area of Lake Ontario, which reduces the risks of entrapment of fecal contamination within the swimming area. The prevailing currents flow east and the prevailing winds in the area are out of Southwest, which could lead to some entrapment of contaminants along the shore, as there are three CSOs to the west of the beach (two at the Cataraqui Wastewater Treatment Plant and one at Greenview Drive, upstream from where Little Cataraqui Creek discharges into Lake Ontario). Furthermore, Hospital Beach is located on a slight bay. This could lead to the entrapment of some contaminants by partially blocking the flow of water to the east (Figure 4).

Figure 4. Map of Kingston waterfront between Portsmouth Olympic Harbour (east) and Sand Bay (west), featuring Hospital Beach and nearby CSOs. Prevailing winds and prevailing currents are marked.

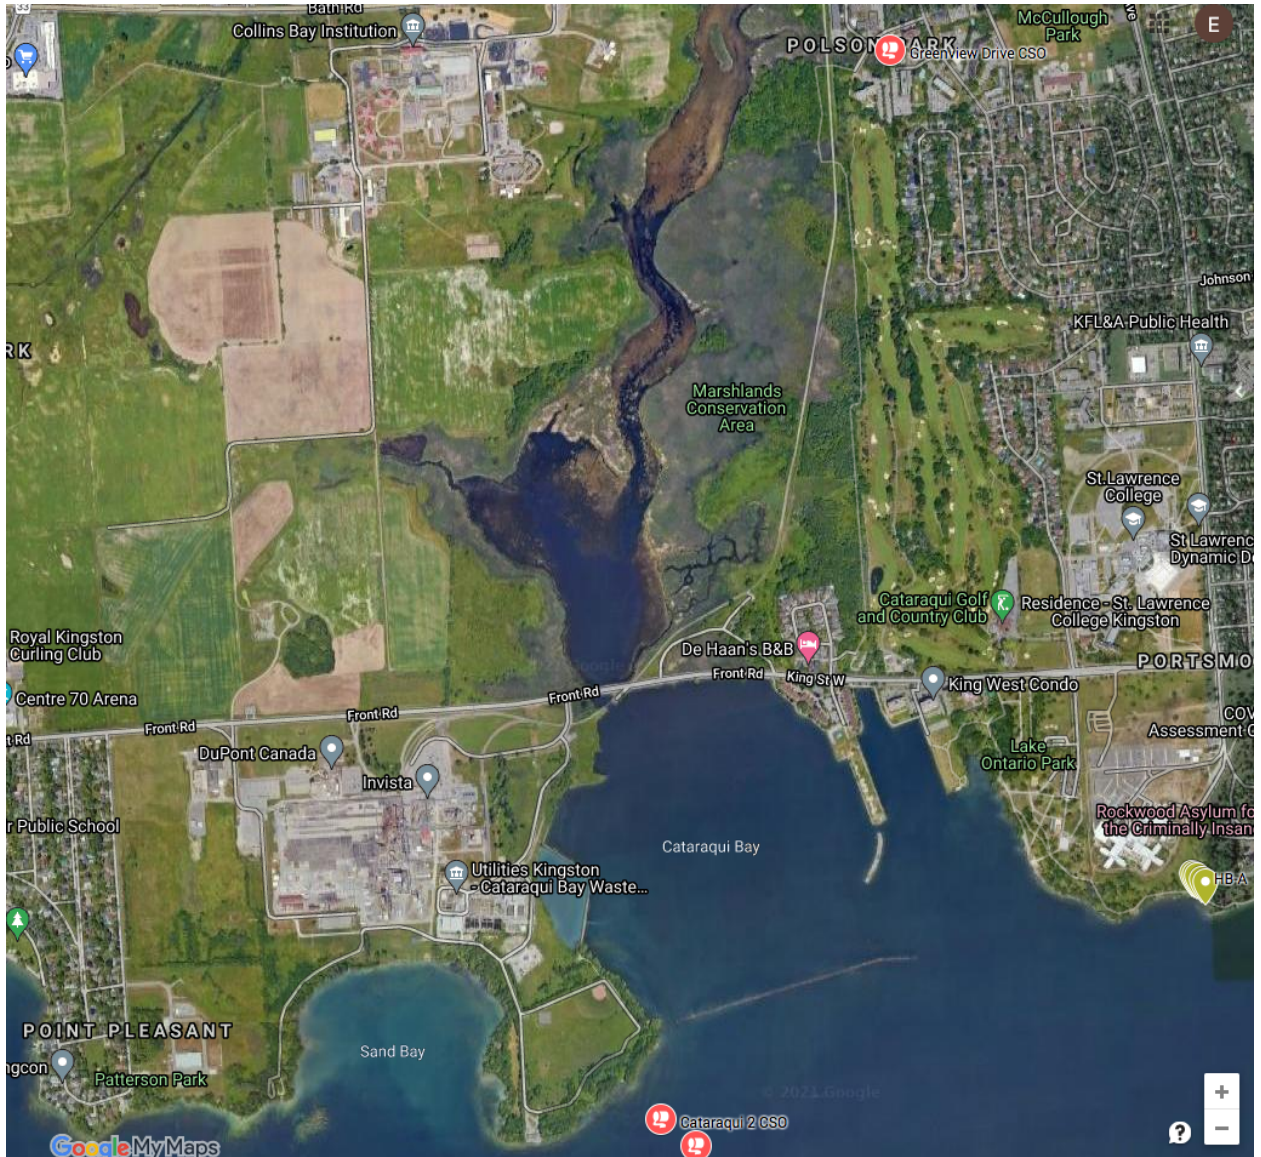
- There are three combined sewer outfalls (CSOs) located along Little Cataraqui Creek. The creek flows into Lake Ontario at Cataraqui Bay, approximately 1 km west of Hospital Beach. While the closest of these three outfalls is located about 2 km upstream from the creek outlet (Greenview Drive CSO, Figure 5), overflows have the potential to affect water quality at Hospital Beach due to Lake Ontario's easterly currents (Figure 4). There are also two combined sewer outfalls that discharge into Lake Ontario at the shoreline just south of the Cataraqui Bay Wastewater Treatment Plant. These are located about 1.5 km west of Hospital Beach. Again, due to Lake Ontario's easterly currents, overflows at these two sites have the potential to affect water quality at Hospital Beach. Data Utilities Kingston, suggest that CSOs in the Kingston area occur largely after heavy rainfall (Table 1).

- *Cataraqui Bay Wastewater Treatment Plant*
 - The Cataraqui Bay Wastewater Treatment Plant is a conventional activated sludge secondary treatment facility located on Cataraqui Bay (Figure 5). The treatment plant services the west end of Kingston and is currently undergoing upgrades to accommodate growing population and the redirection of wastewater from parts of central Kingston. The upgrading of the facility was noted as a priority in the 2010 Sewage Infrastructure Master Plan. Construction started in October 2016. As of March 3, 2022, construction was 90% complete.³ There are no new updates on when the project will be complete.

Figure 5. Hospital Beach (green); Utilities Kingston - Cataraqui Bay Wastewater Treatment Plant (grey); and three CSOs (red): Catawaqui 1, Catawaqui 2, and Greenview Drive.

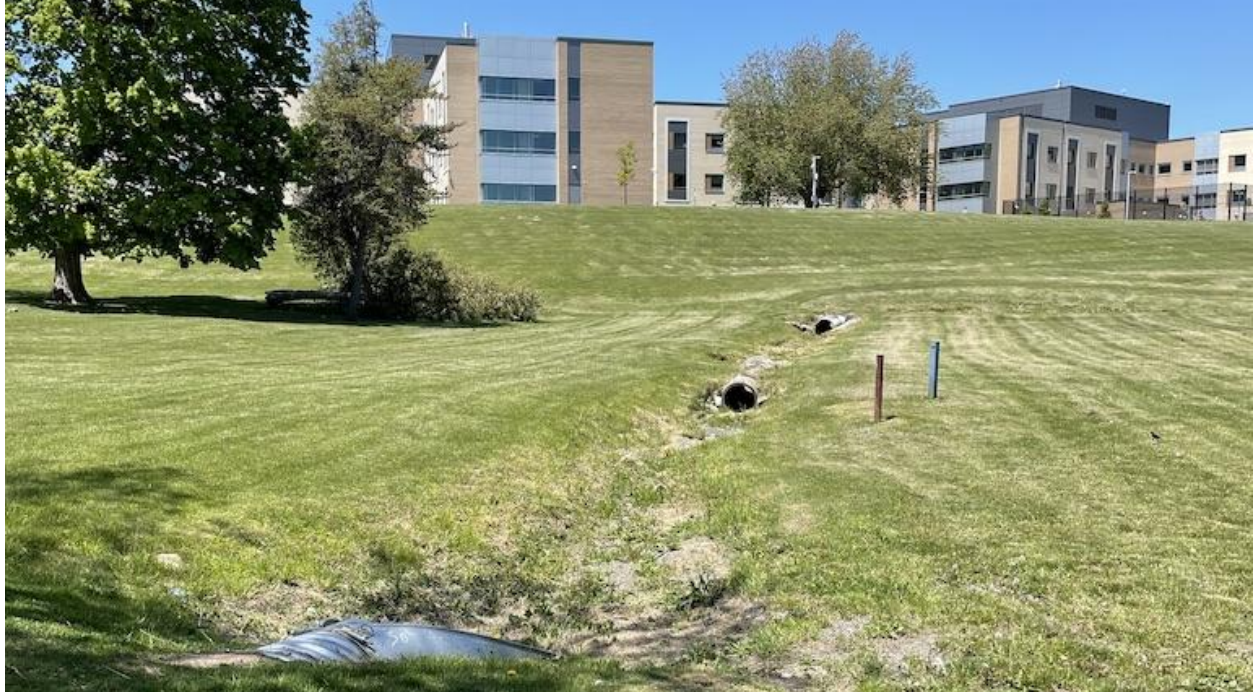
- Stormwater runoff from the surrounding land has the potential to affect water quality at Hospital Beach due to the large stormwater pipes flowing directly into the swimming area, near sample site C (Figure 6&7). Runoff from the Providence Care Hospital parking lot

Figure 6. Stormwater Drain Pipe located downhill from Providence Care Hospital and into the swimming area of Hospital Beach.

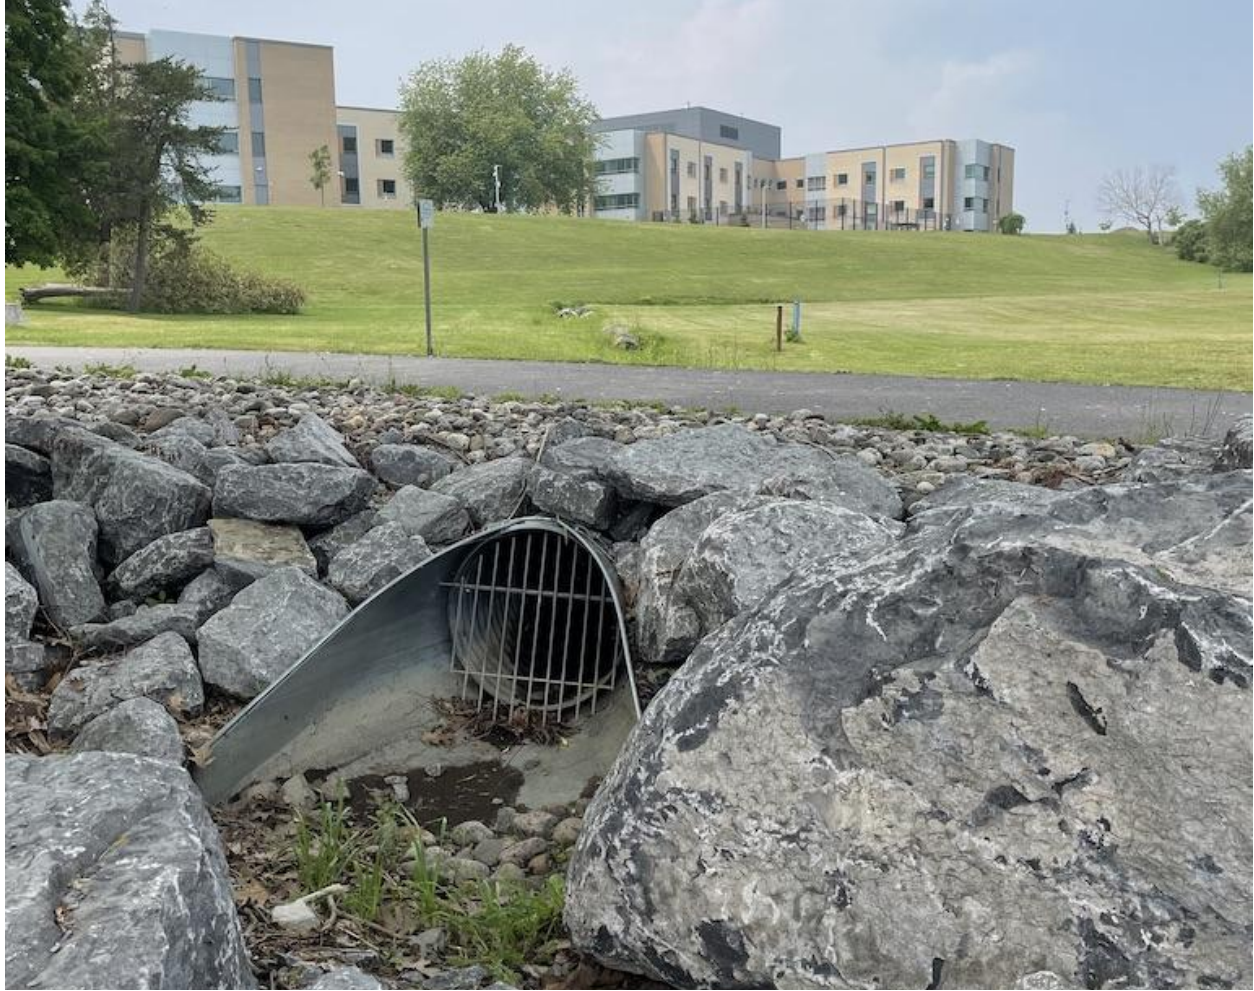
Figure 7. Stormwater Drain Pipe located downhill from Providence Care Hospital flowing directly into the swimming area of Hospital Beach.
