# Arrowhead Beach Park - 2023

**Name:** Arrowhead Park Beach

**Responsible Authority:** Swim Drink Fish Canada - Kingston Water Monitoring Hub

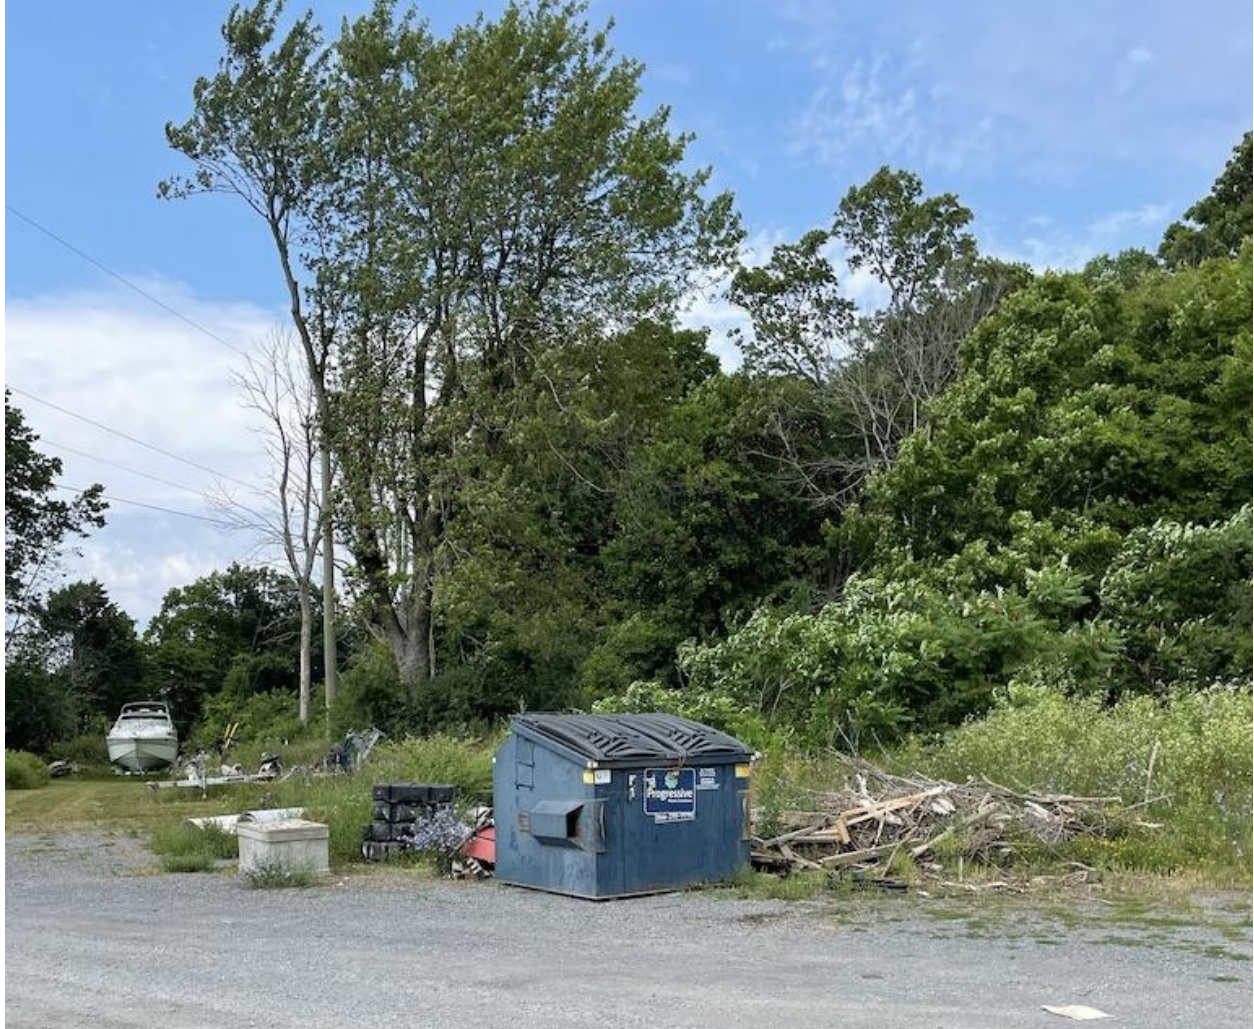
**Figure 3.** The Yacht Club Clubhouse Dumpster located in the Northwest corner of the parking lot.

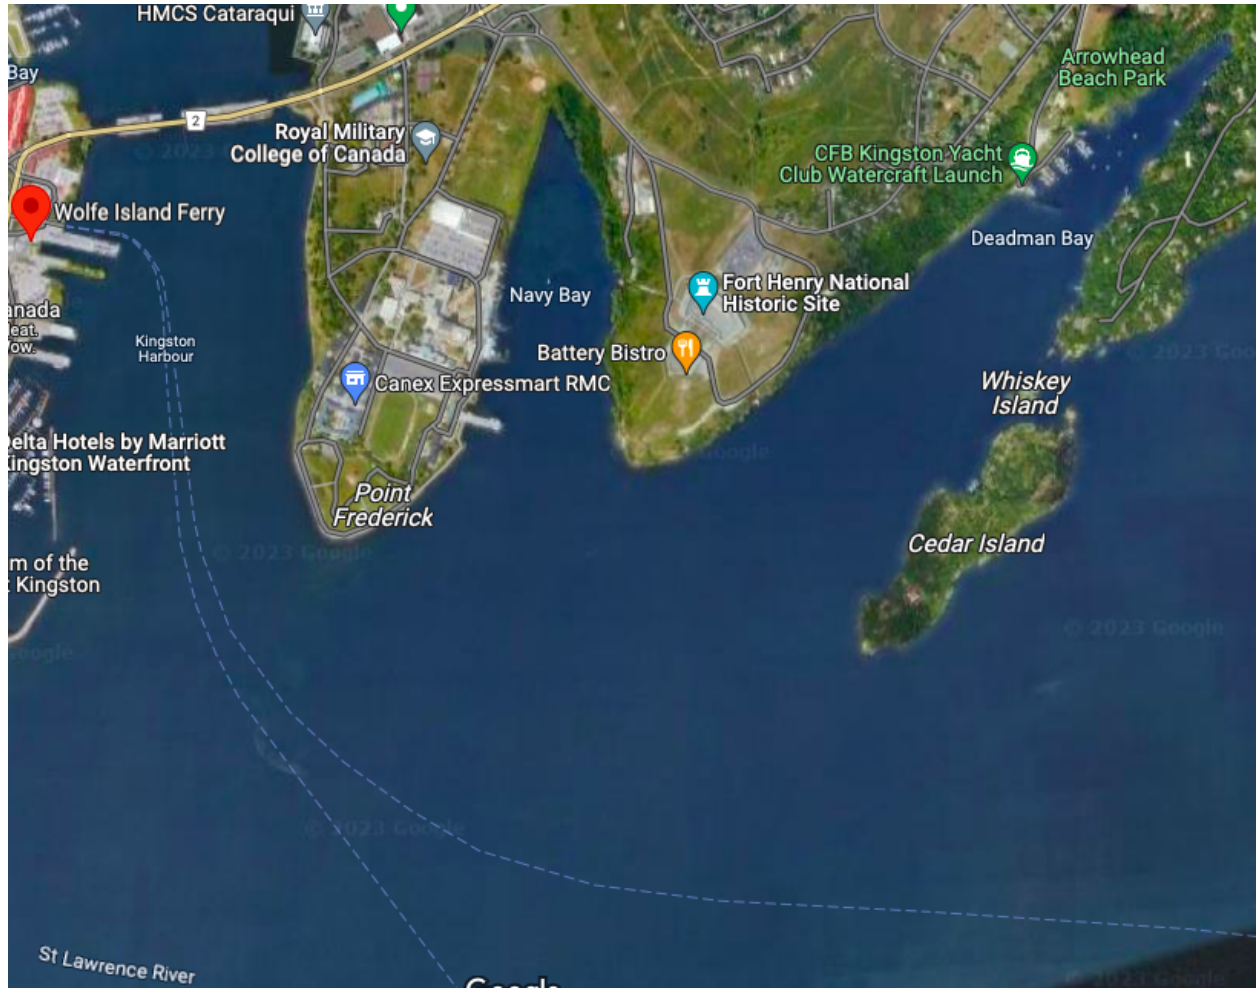
**Figure 4.** Kingston-Wolfe Island Ferry Route (route is indicated through the blue dotted line pathway) passing close to Deadman Bay, where Arrowhead Park Beach is located.

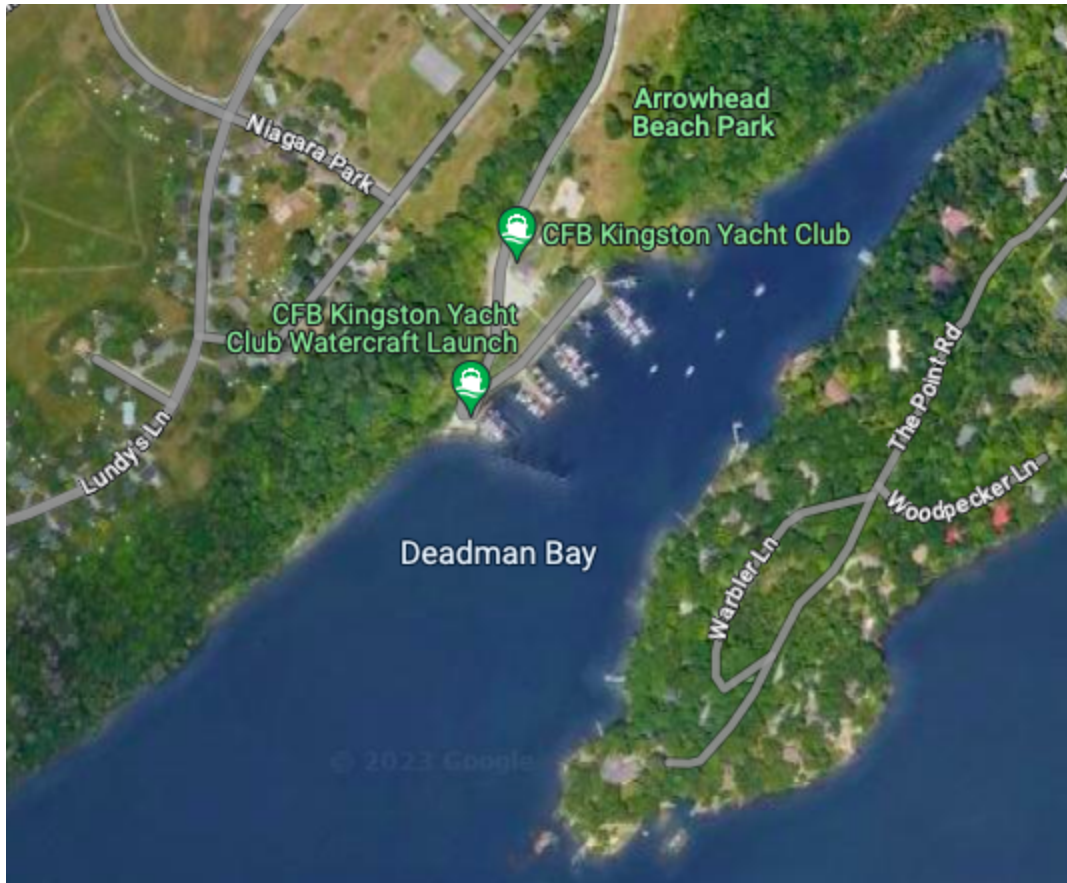
Based on the watershed of Arrowhead Park Beach, stormwater runoff from multiple commercial, parkland, and parking lot areas pose a risk for potential upstream pollution. The Kingston-Wolfe Island Ferry may contribute to biological, chemical and physical contaminants from the large watercraft waste tank, boat fuel, cleaning chemicals, and a possible increase in litter from ferry commuters that may end up in the water. The ferry docks in the water just off of Barack St., and the route from Kingston to Wolfe Island passes the west edge of Deadman Bay (Figure 4), where Arrowhead Beach is located at the far East end of the Bay. With both the boat flow and the prevailing winds coming from the west, there is a potential for these upstream pollutants to flow directly into the Bay and contaminants may end up close to the marina or the swimming area. Due to the beach area being located in Deadman's Bay, there is a strong potential for contaminant entrapment, as there is no opening at the east edge of the bay (Figure 5).

**Figure 5.** Arrowhead Park Beach located on the Northeast end of Deadman Bay where there is no flow back out into the river from the east side. There is a potential risk for contaminants to become entrapped in the Bay.

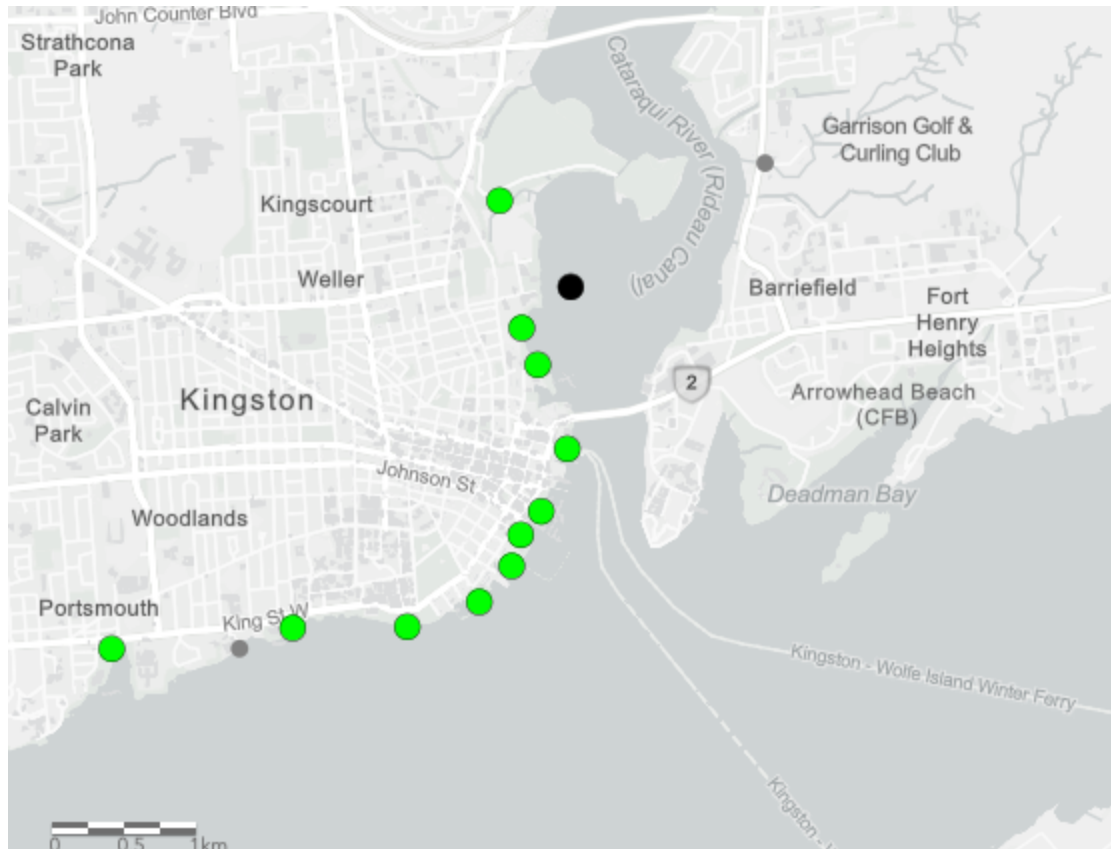
- There are no CSOs located at Arrowhead Park Beach.
- All CSOs are located a significant distance away from the beach and are not classified as a strong risk. All combined sewer outflows are located on the west side of the Cataraqui River (Figure 6). See the CSO Map provided by utilities Kingston.<sup>1</sup>

**Figure 6.** Map of combined sewer outfalls (CSOs) nearest to Arrowhead Park Beach. All CSOs are located on the west side of the Cataraqui River, a significant distance from the beach.
