Accidental Beach (Cloverdale Beach), Edmonton, AB

Site Information and Background:

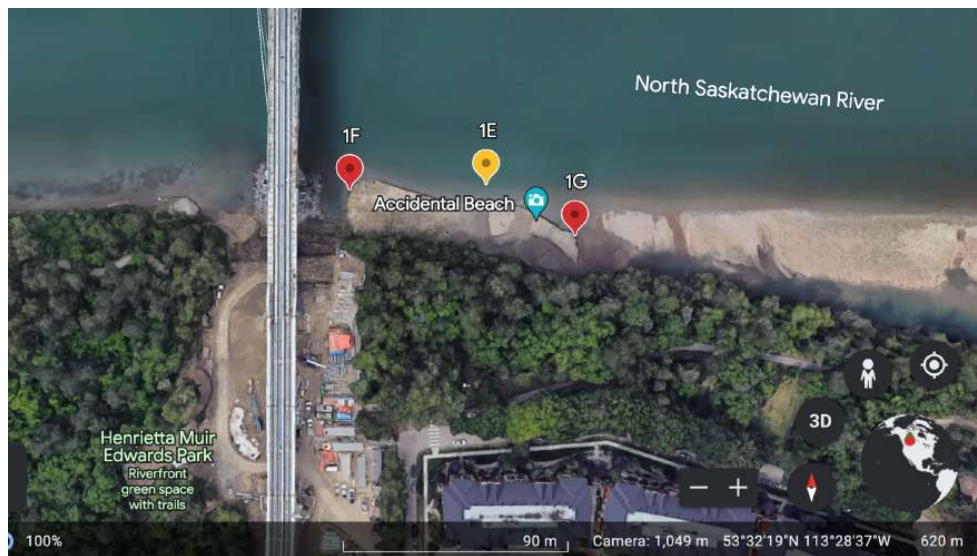
Figure 1a: Sampling points 1A-1D have been deactivated this year as the sediment forming the eastern portion of Accidental Beach has been swept away. Point 1E is still accessible and will be reused for the 2023 monitoring season. New sampling points 1F and 1G have been established on the western portion of the beach on either side of 1E, following the Alberta Safe Beach Protocol recommendations of 3 points on beaches 100m or less in length.

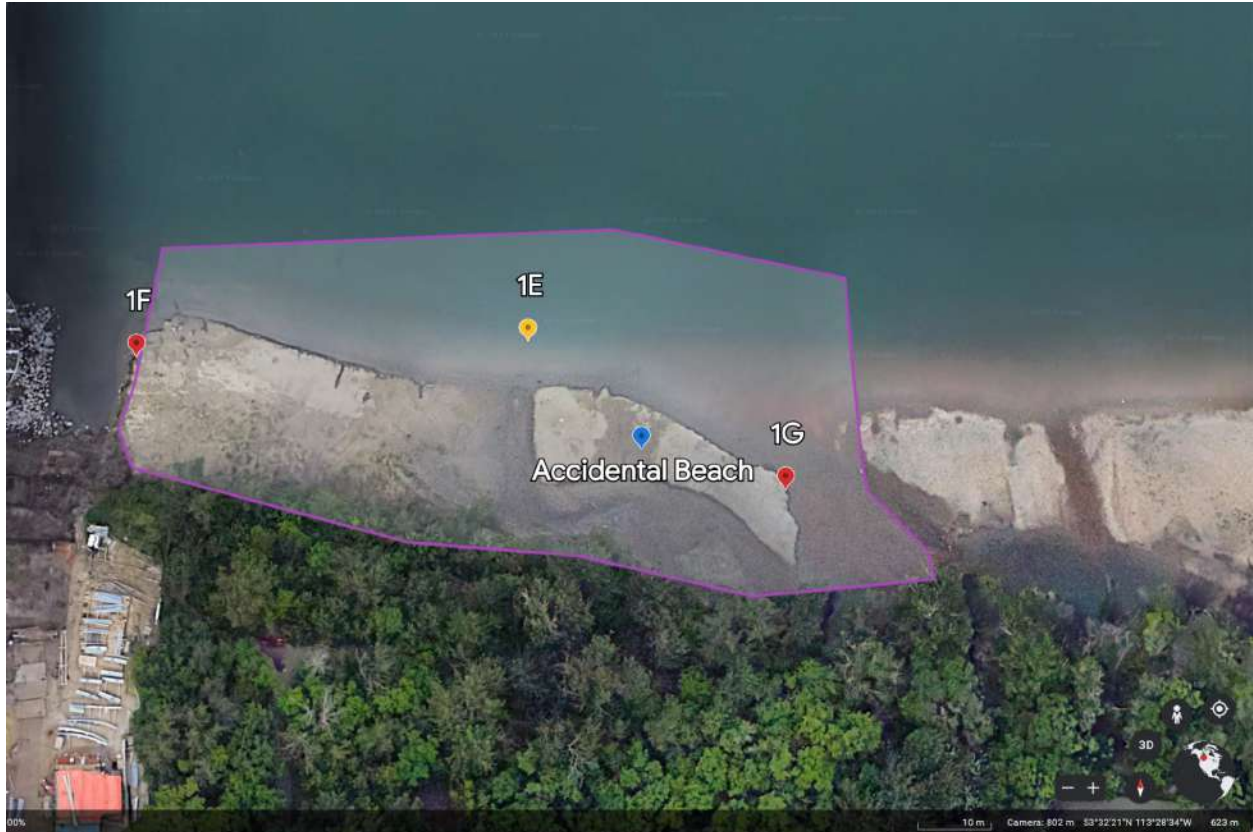
Figure 1b: Map of Accidental Beach sampling site including zone of local influence.

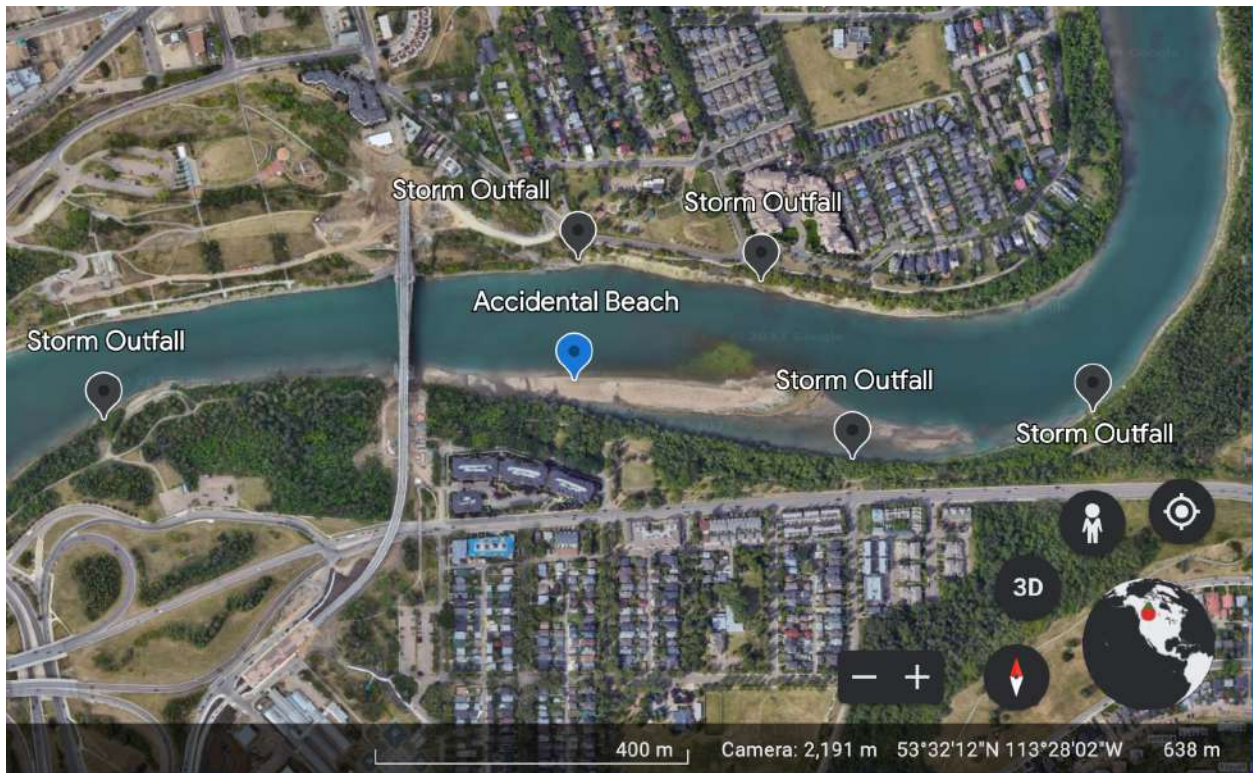
There is one stormwater outfall 600m upstream and one directly across the river from Accidental Beach (Figure 3). These outfalls could be discharging faecal, chemical, or other types of contamination, which may have an effect on water quality at Accidental Beach. The Edmonton Riverboat runs boat tours of the North Saskatchewan River starting from a location .5km upstream from the beach. The Riverboat and other motorized watercraft could be a potential source of chemical pollution that could be impacting the water quality at this site. There is a buffer of forested park area along the rivers edge directly upstream from this site, however, there are a lot of paved surfaces (major roads, bridges, sidewalks etc.) upstream that could still pose a risk of contamination from runoff at this site.

Figure 3: Map of storm outfalls surrounding the Accidental Beach site. Data obtained from City of Edmonton open datasets ([Drainage \(Map View\): Outfall | Edmonton - Open Data Portal](#)).

- There is one stormwater outfall just upstream from Accidental Beach and one across the river (Figure 3). These outfalls could be a potential source of both faecal and chemical contamination as the areas surrounding the beach are highly urbanized and residential with high amounts of impermeable surfaces. This risk will likely increase following rainfall events.

- The stormwater outfalls upstream of the site (Figure 3) could potentially carry chemical contaminants from surrounding urban and residential areas during rainfall events. There are also urban and residential areas surrounding the site which could be a potential source of chemical contamination, however, there is a forest buffer that would help to protect the beach from this.

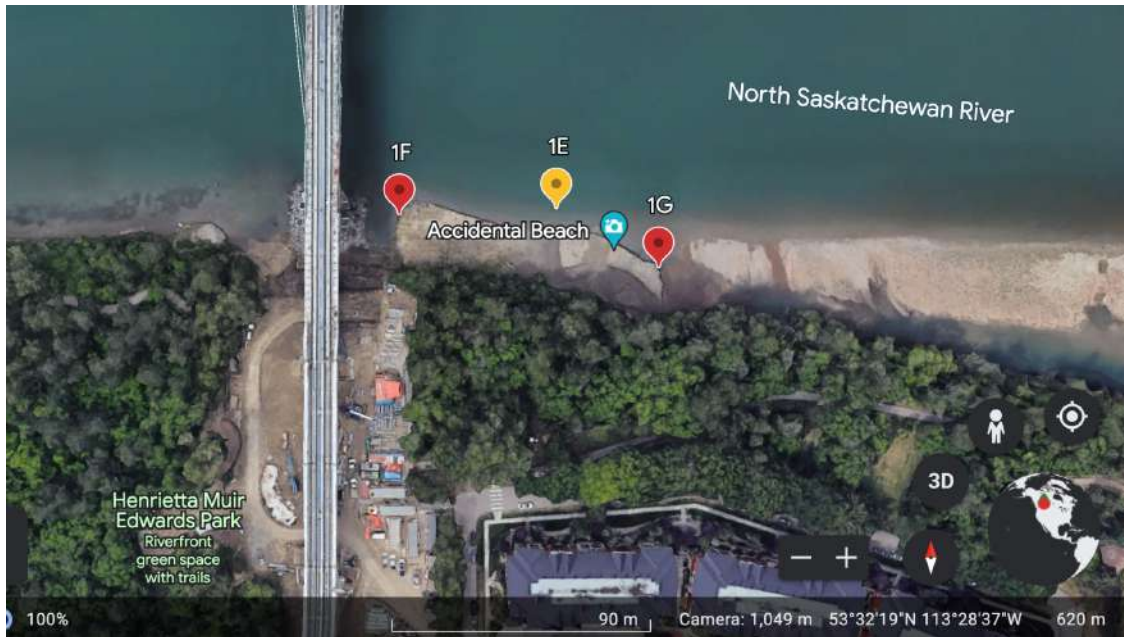
Figure 1a: Sampling points 1A-1D have been deactivated this year as the sediment forming the eastern portion of Accidental Beach has been swept away. Point 1E is still accessible and will be reused for the 2023 monitoring season. New sampling points 1F and 1G will be established on the western portion of the beach on either side of 1E, following the Alberta Safe Beach Protocol recommendations of 3 points on beaches 100m or less in length.

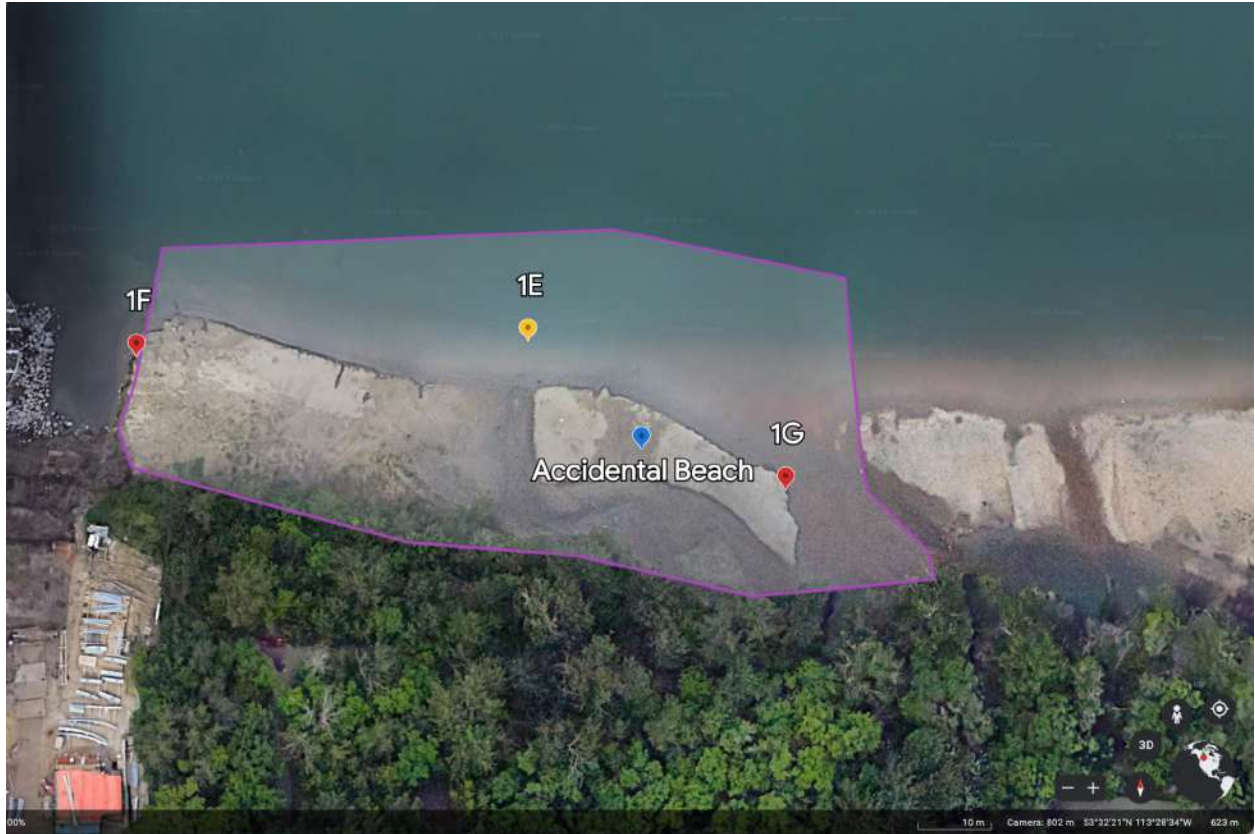
Figure 1b: Map of Accidental Beach sampling site including zone of local influence.

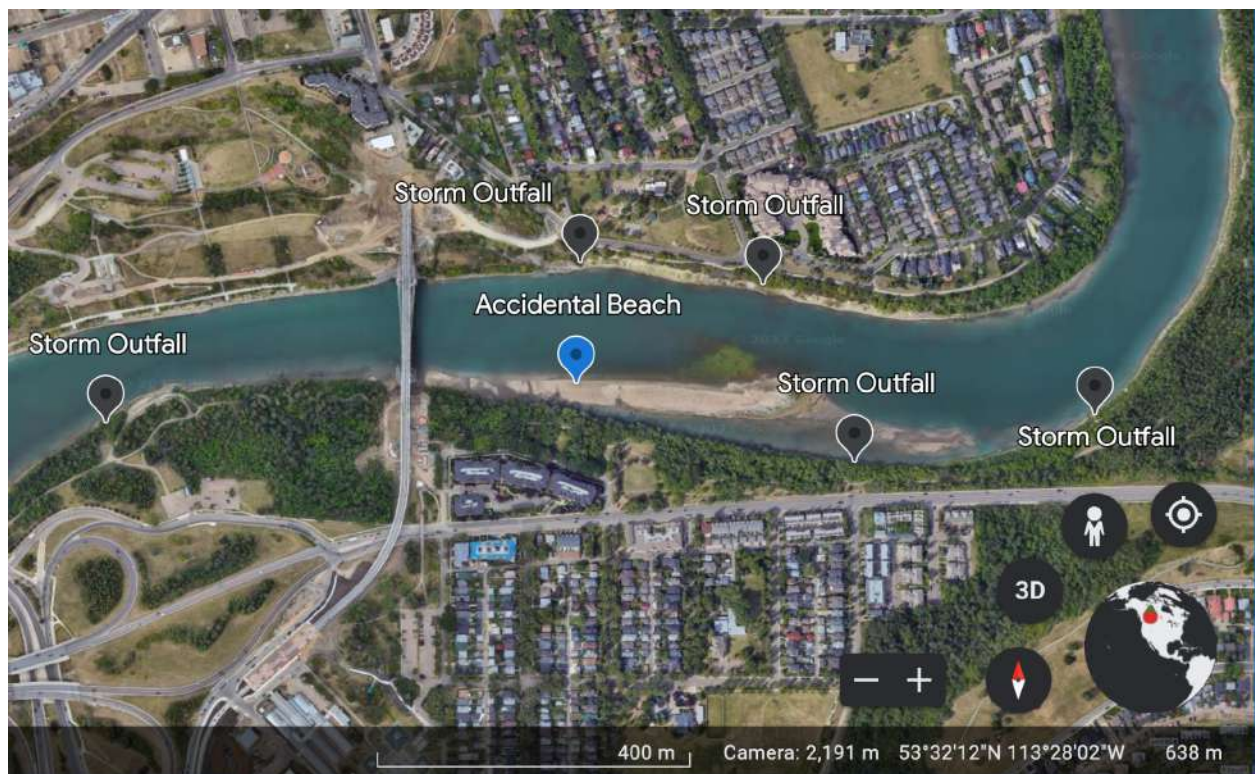
Figure 3: Map of storm outfalls surrounding the Accidental Beach site. Data obtained from City of Edmonton open datasets ([Drainage \(Map View\): Outfall | Edmonton - Open Data Portal](#)).
