Sir Wilfred Laurier 2023

Site Information and Background:

Name: Sir Wilfred Laurier Park

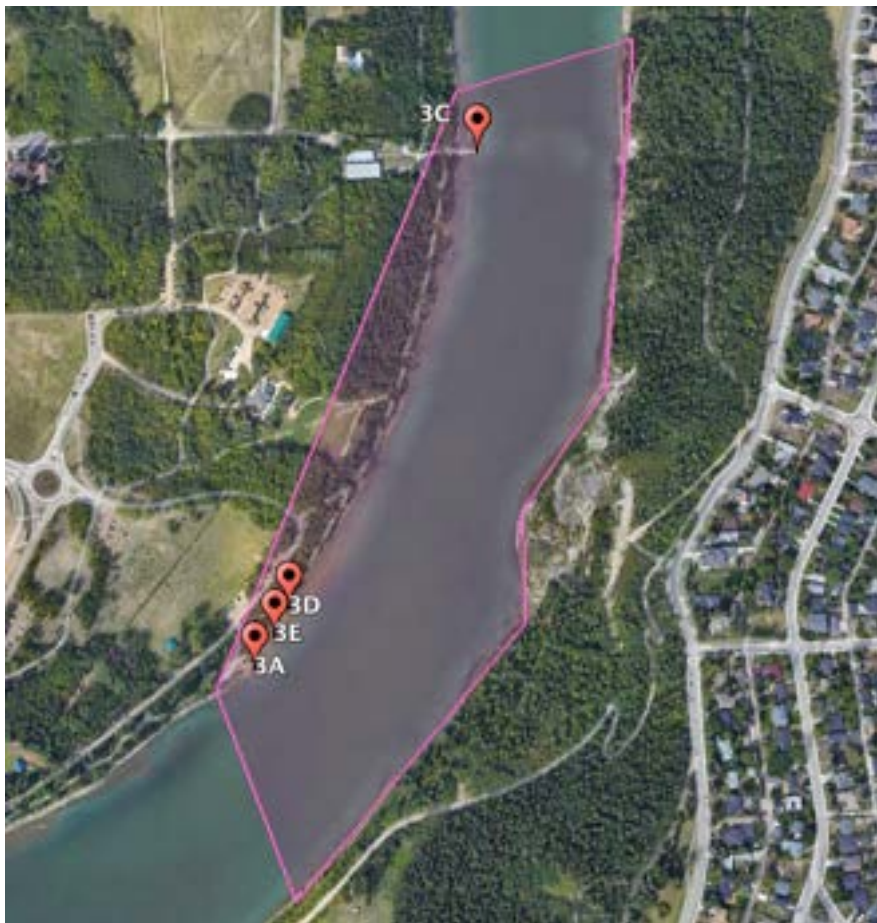
Figure 1: Map of monitoring points at Sir Wilfred Laurier Park. Three samples will be taken at the beach area near the Wilfred Laurier boat launch: one on the boat launch (3A), one at the base of the stairway to the waterfront (3D), and one in the center of the beach connecting these points (3E). An additional sample will be taken at the Edmonton rowing club dock downstream from these sites. Previous sampling point 3B was deactivated as bank erosion has made it inaccessible.
